Lymphoma — A cancer under control

LYMPHOMA CASE STUDY

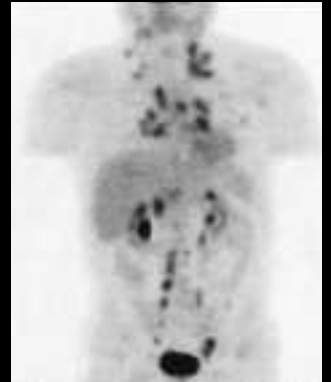
PRE-TREATMENT PET IMAGE

Patient History: 29-year-old male patient with a history of lymphoma, recurrent after chemotherapy and stem cell transplantation. After the initial PET showed extensive metastatic disease (wide spread cancer), patient underwent repeat stem cell transplantation. The follow-up PET scan shows a complete response to the transplant, indicating the disease is in remission.
